Title: Replacing Door Hinges for recall of HRF266N6CSE Units	
Creation Date: May 24, 2022	Service Pointer Number: HRF-01-09-2021R
Revision Date:	Models: HRF266N6CSE
Symptom: All Original Hinges Are Recalled and Must be Replaced

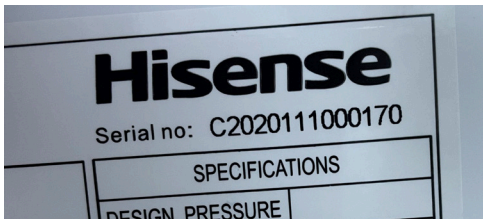
See chart below for model information and serial date range. Also listed below is an example serial code and how to decipher a Hisense refrigerator serial date code.

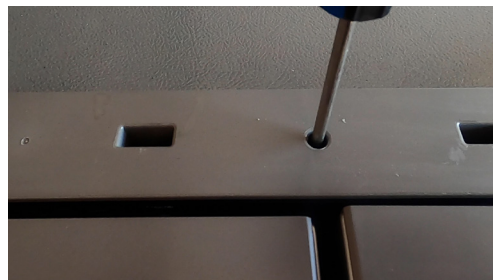
1. Power off the unit.
2. Remove 3 Phillips (+) screws across the holding the table top hinge cover.
3. Move hinge cover to side.

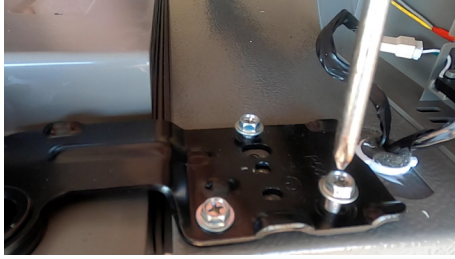
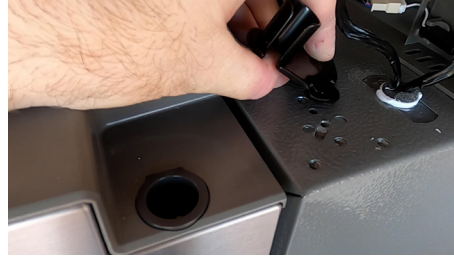
4. Remove 3 Phillips (+) screws holding the top hinge mount. Be sure to hold door to keep it from falling. Remove top hinge.

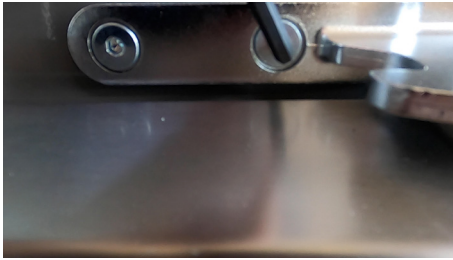
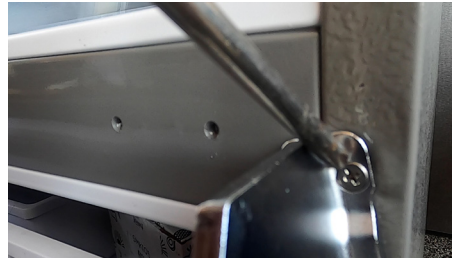
6. Remove 2 ALLEN screws and 1 Phillips (+) screw holding bottom door hinge on cabinet.

7. Attach new hinge and remount door by completing steps in reverse order. Being sure to properly lubricate the new hinge.
