Hisense RF20N6ASE Electric Wind gate or Damper Replacement Procedure 06/03/2016

Problem: Freezer cools but the refrigerator remains warm.

Cause: The electric wind gate gets stuck in the closed position blocking the airflow from the freezer to the refrigerator.

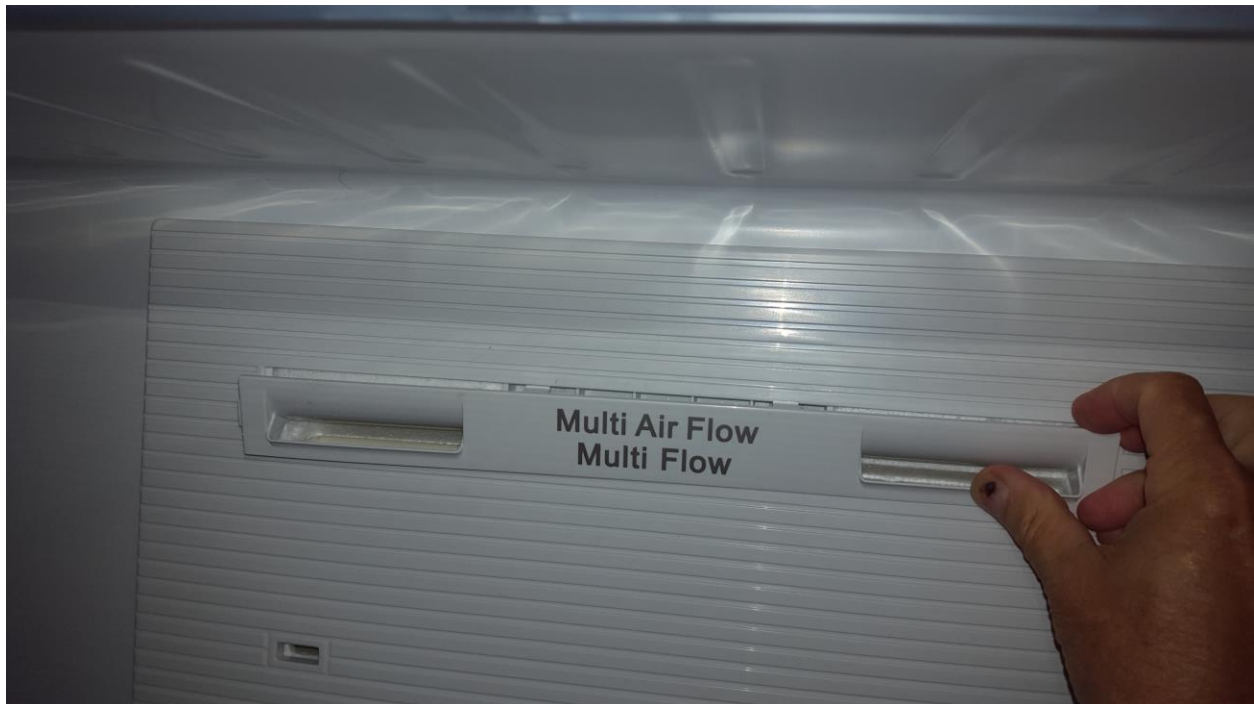
1. Remove all shelving and drawers.

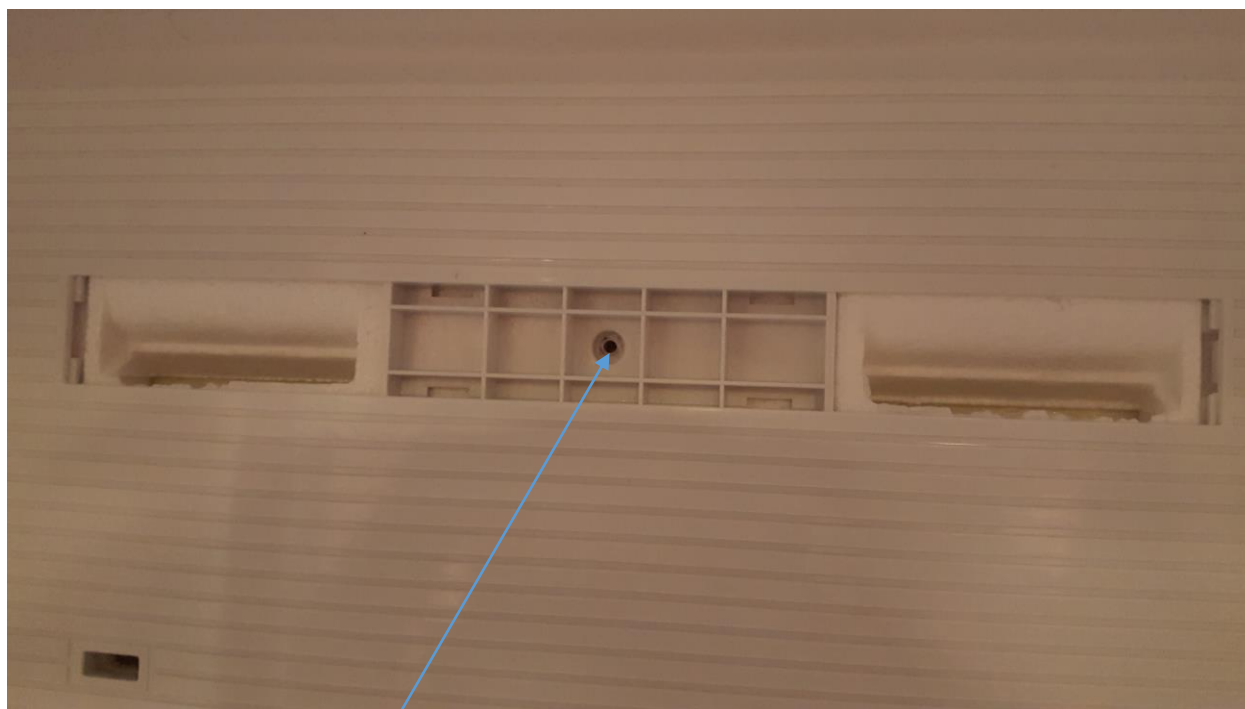
2. Remove the #17 (parts list) decorative strip-drawing Part# 1626059 by carefully prying it off.

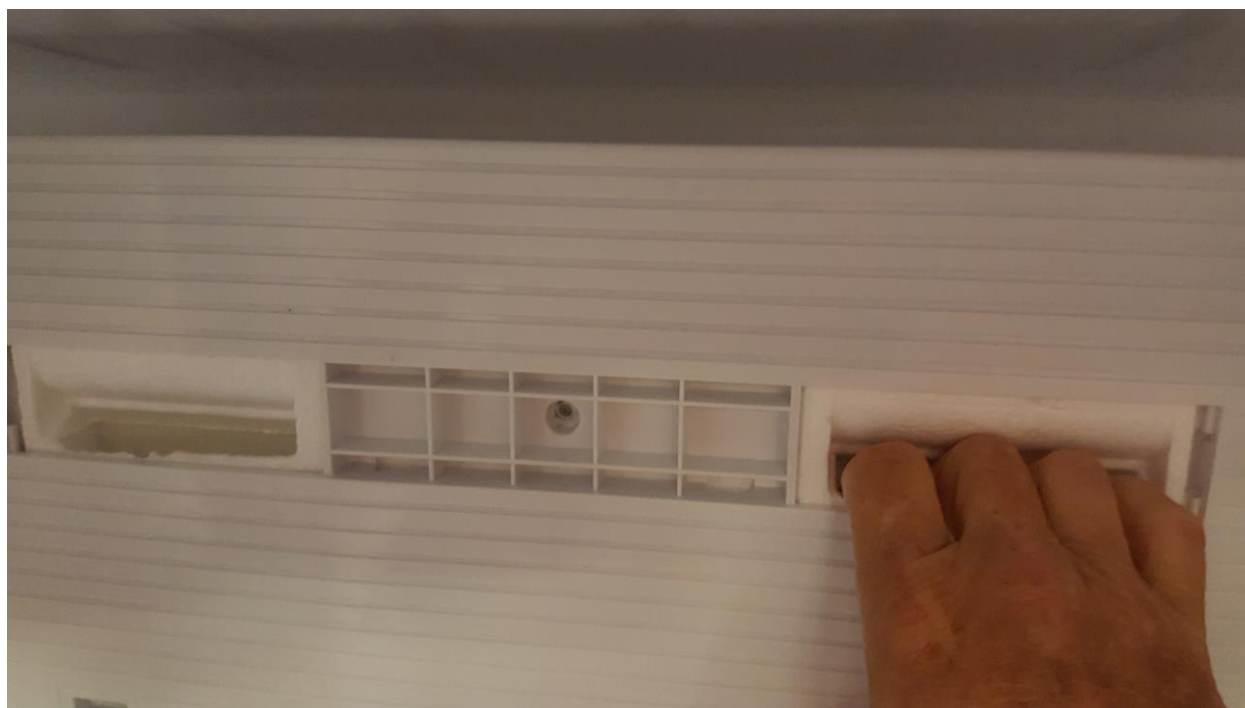
3. Remove center screw

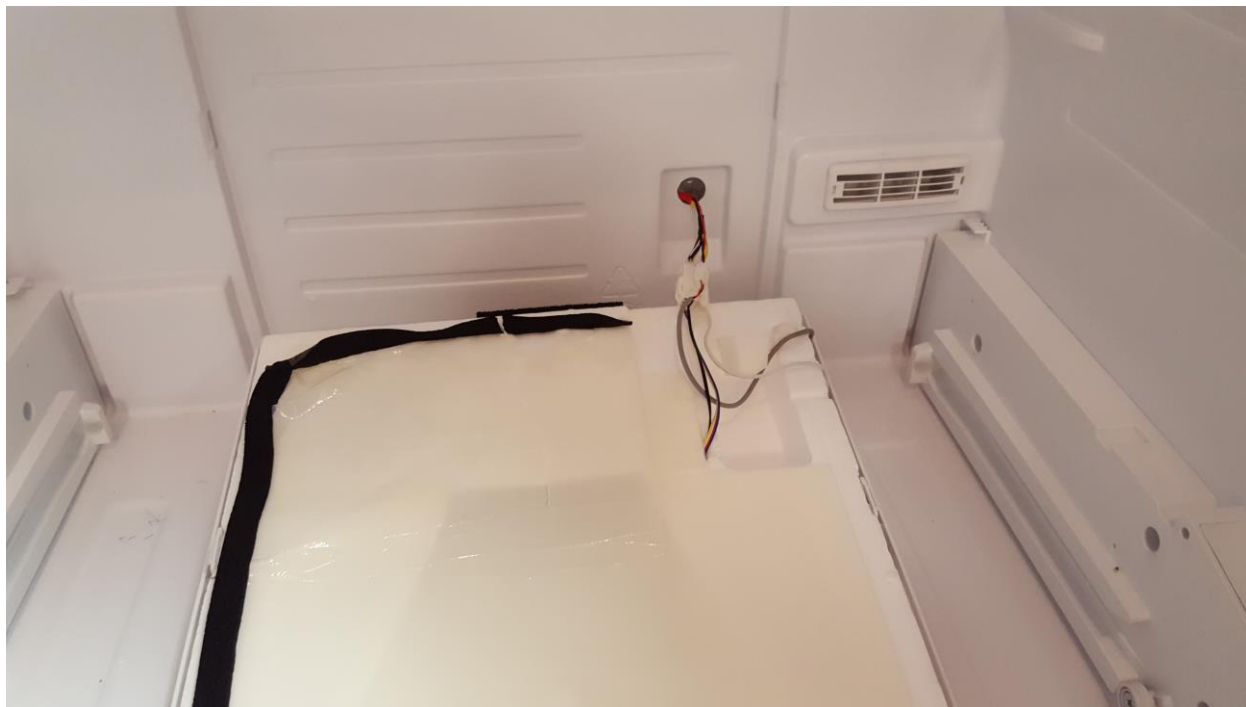
4. Gently remove the refrigerator air duct cover – Part #1539394

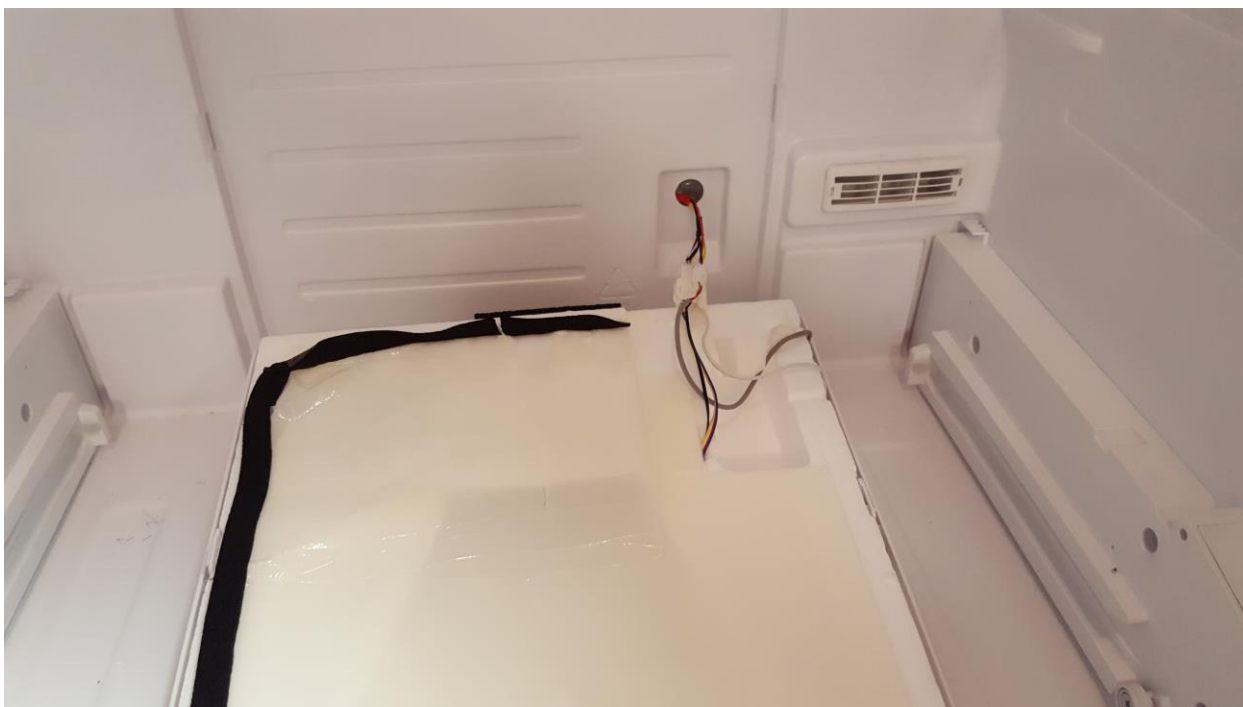
5. Disconnect 3 connectors that go to the LED light, Temperature Sensor and Wingate Motor and remove Air Duct cover.

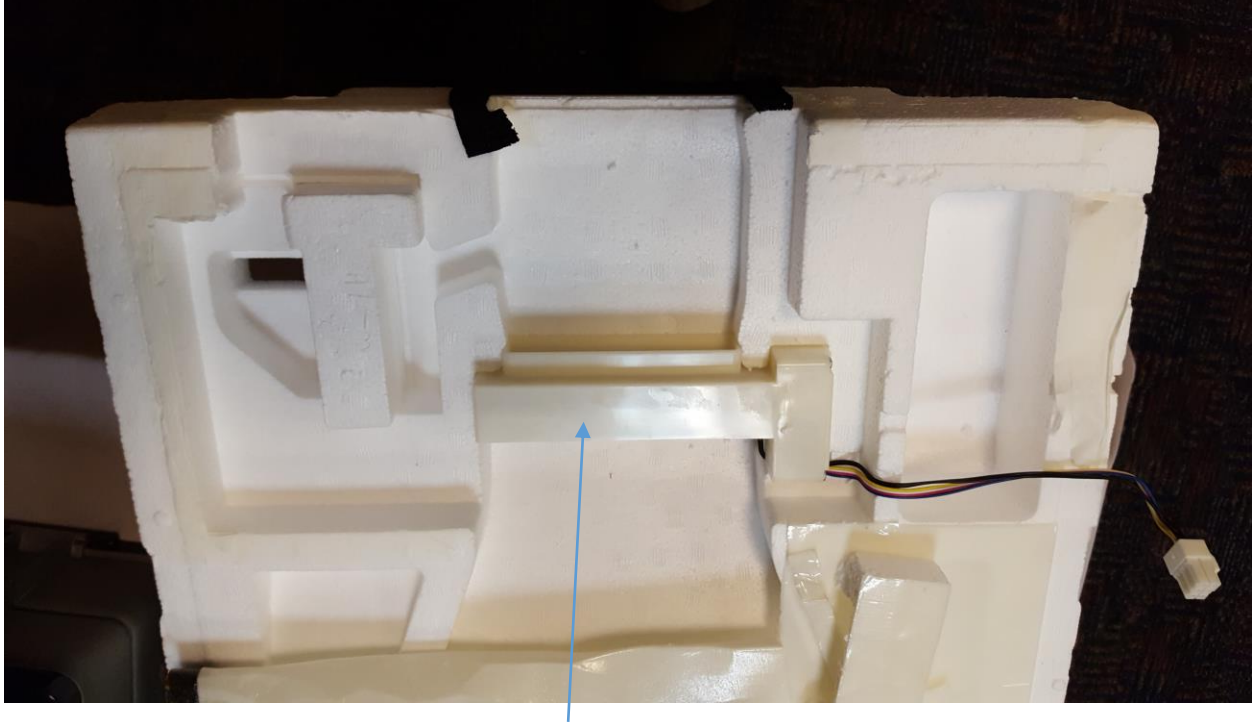
6. Remove the thin insulation tape and plastic cover over the air duct.

7. This view is inside the air duct with Styrofoam cover removed. Replace Wingate motor assembly. You can test that the wind gate motor is functioning by reconnecting the motor and sensor then watching the gate close while the door is open. It will open again after the refrigerator door is closed and you should be able to hear it close. The compressor must be running for the wind gate to close. Reverse the process to reassemble. You can use clear packing tape if the plastic cover should tear while removing it.
