## **Technical Service Pointer**

Title: Crisper Drawers Pulling Away From Side Walls	
Creation Date: January 14, 2021	Service Pointer Number: HRF-14-01-2021
Revision Date:	Models: Listed Below / 2019 To Present Production
Symptom: Crispsers Not Closing, Crisper Drawer Falling Out

Models: HBM17158SS

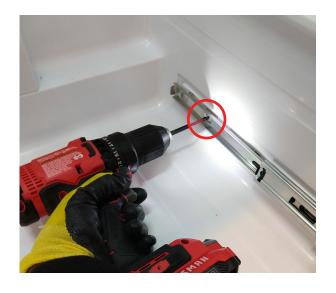
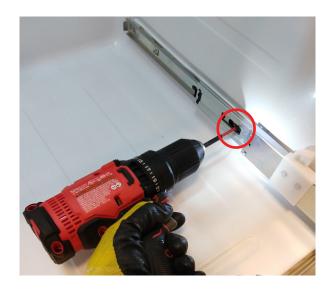
1. Remove crisper drawer. Once crisper drawer is removed, locate the 2 screws holding the glide rails in place and remove.
