Title: <b>Inverter and Compressor Update</b>	
Creation Date: September 7, 2021	Service Pointer Number: <b>HRF-07-09-22</b>
Revision Date: November 14, 2022	Models: See Table Below
Symptom: poor cooling, no cooling

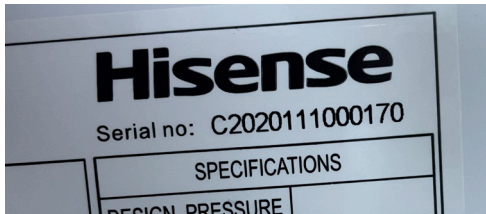
See chart below for model information and serial date range. Also listed below is an example serial code and how to decipher a Hisense refrigerator serial date code.

C
YYYY
MM
DD
00001

Line
Year
Month
Day
Production Number

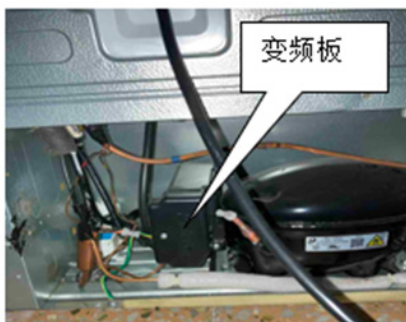
Original Board Location

There has been an update to the compressor & inverter board on newer HRF266/HRF254 units. Please check the serial number to ensure the correct parts are ordered. See the chart below for the serial number range and new part numbers.
